Nomination for Waters  
Important to Anadromous Fish

Name of Waterway Billmeir Lake/Creek Tributary to The Sagavanirktok R

# ADOT/PF Deadhorse Gravel Pit

## **ADOT/PF Deadhorse Mine Site Fish and Water Quality Monitoring, 1999.**

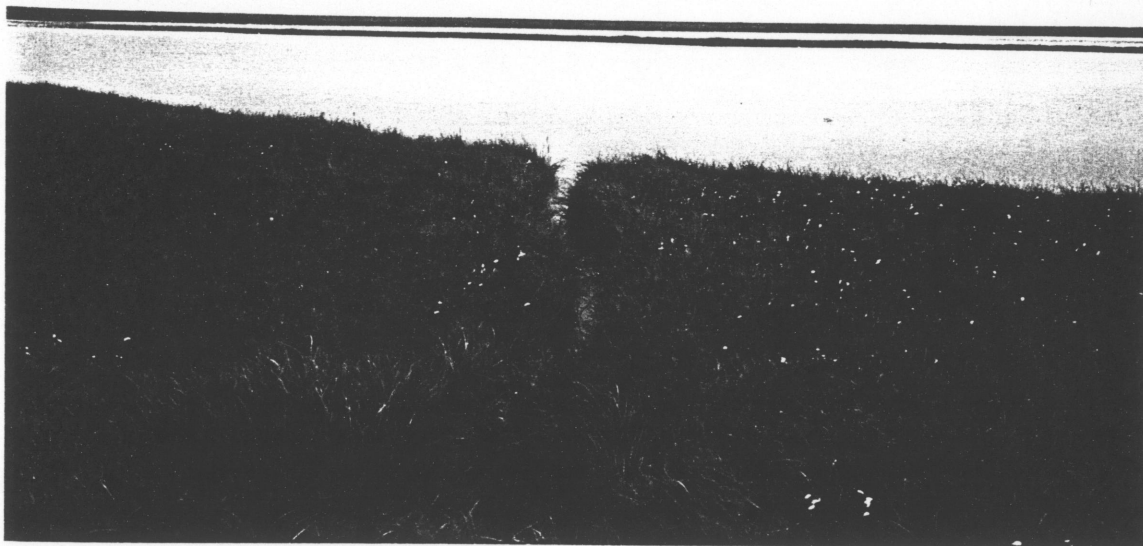
**Figure 2.** Shallow tundra pond upstream of ADOT Deadhorse pit with outlet channel (top), and inlet channel to ADOT pit (bottom).

inlet to the ADOT pit that drains a large shallow lake complex west of the pit (Figure 2). While adult (>300 mm) grayling were not captured in either July or August it is possible that larger fish entered the stream shortly after the spring flood, spawned and moved downstream out of the system into the Sag river or moved upstream into the shallow wetland complex above the pit.

We conducted visual surveys of the outlet channel between the pit and the Sag River on June 16, August 5, and August 26. Fish were not observed in the outlet channel during these surveys. On June 16, the channel had continuous flow with one section between the pit outlet and the Dalton Highway having a one meter cascading drop. It appeared that access to the pit was not obstructed for fish moving upstream from the Sag River in mid June. On August 5 the outlet channel was dry at a point immediately downstream from the Dalton Highway culvert crossing, but continuous flow occurred between the pit and the culvert crossing. On August 26, the outlet channel was continuous between the pit and the Sag River but water depths of only 1 cm were found in the shallow riffle areas.
